# Debris/Ice/TPS Assessment And Photographic Analysis For Shuttle Mission STS-41

(NASA-TM-103814) DEBRIS/ICE/TPS ASSESSMENT  
AND PHOTOGRAPHIC ANALYSIS FOR SHUTTLE  
MISSION STS-41 (NASA) 151 p CSCL 22B

DEBRIS/ICE/TPS ASSESSMENT  
AND  
PHOTOGRAPHIC ANALYSIS  
OF  
SHUTTLE MISSION STS-41

October 6, 1990

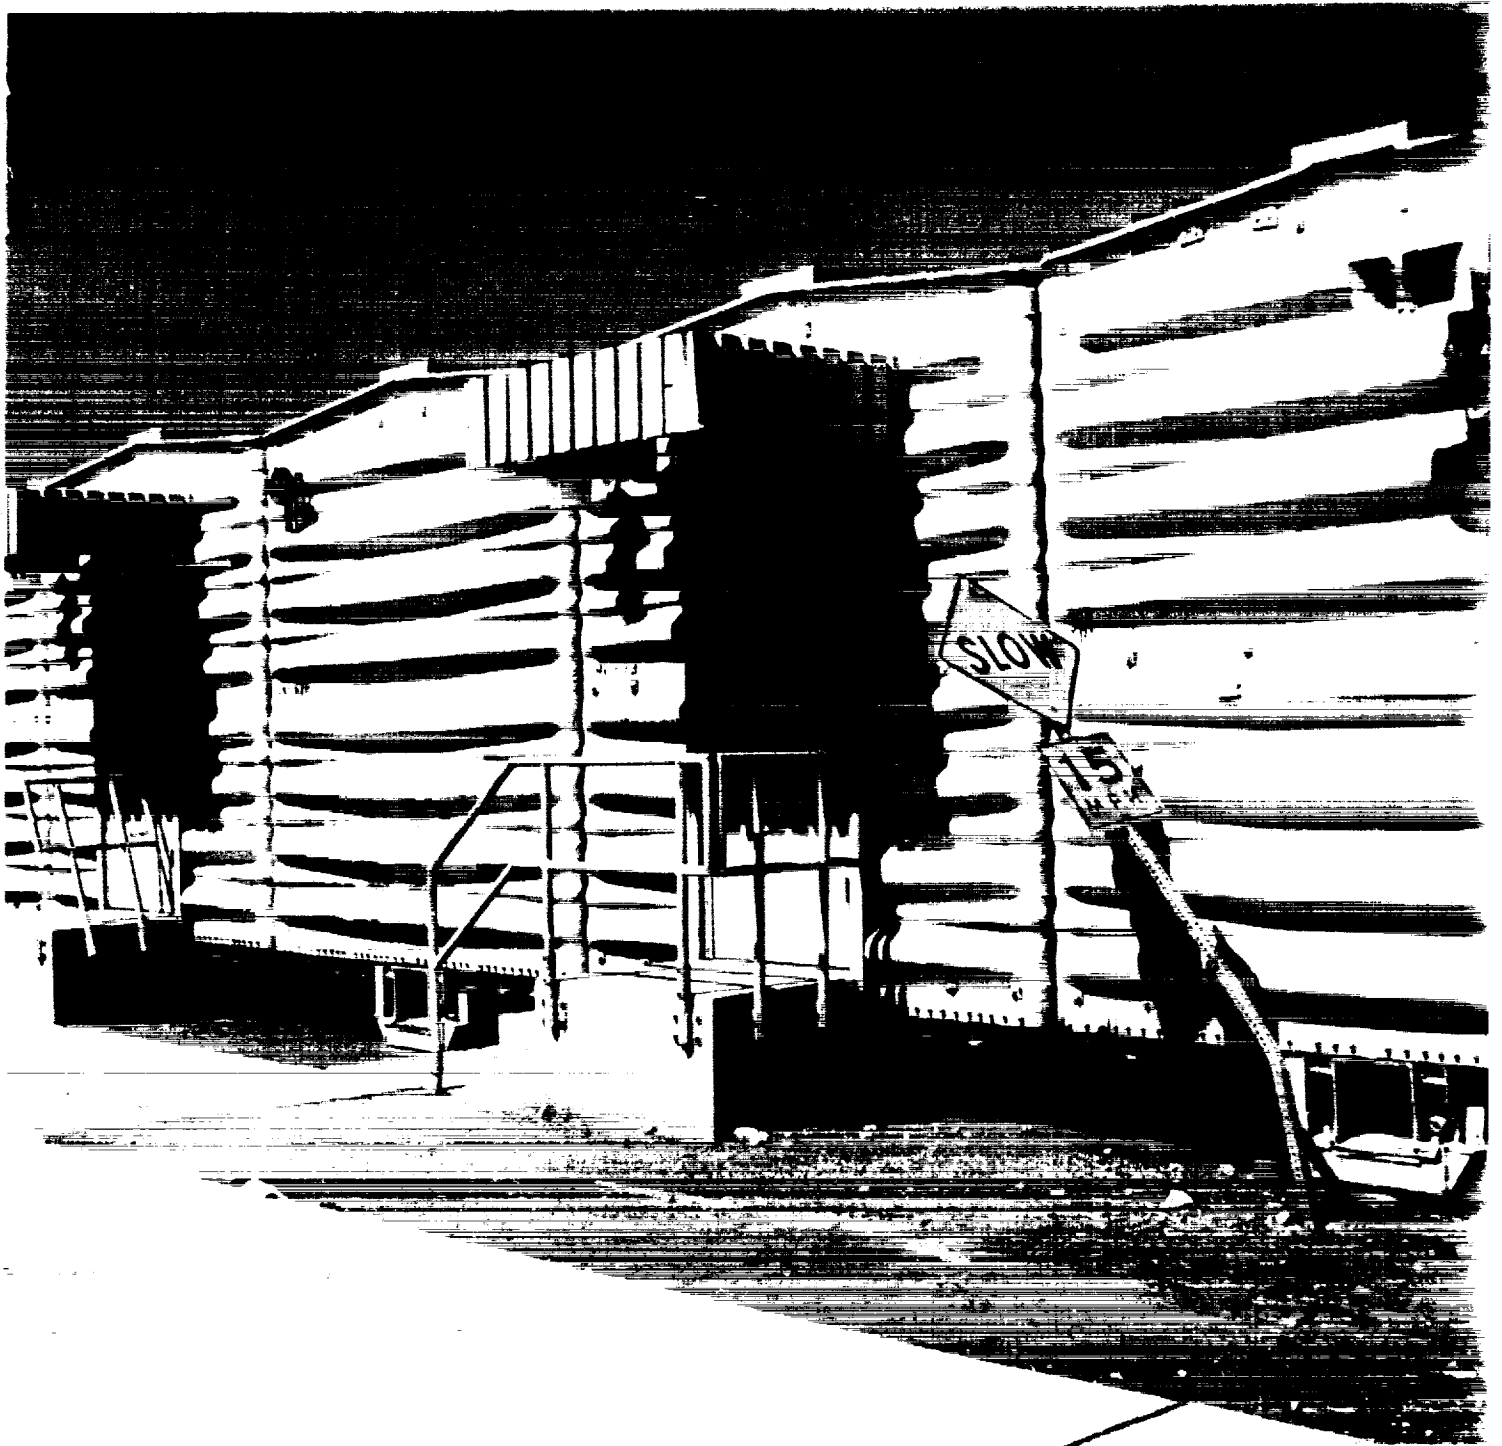
A cable tray cover torn loose from the FSS/RSS by the SRB plume  
impacted a traffic sign, boxcar door, and hand rail

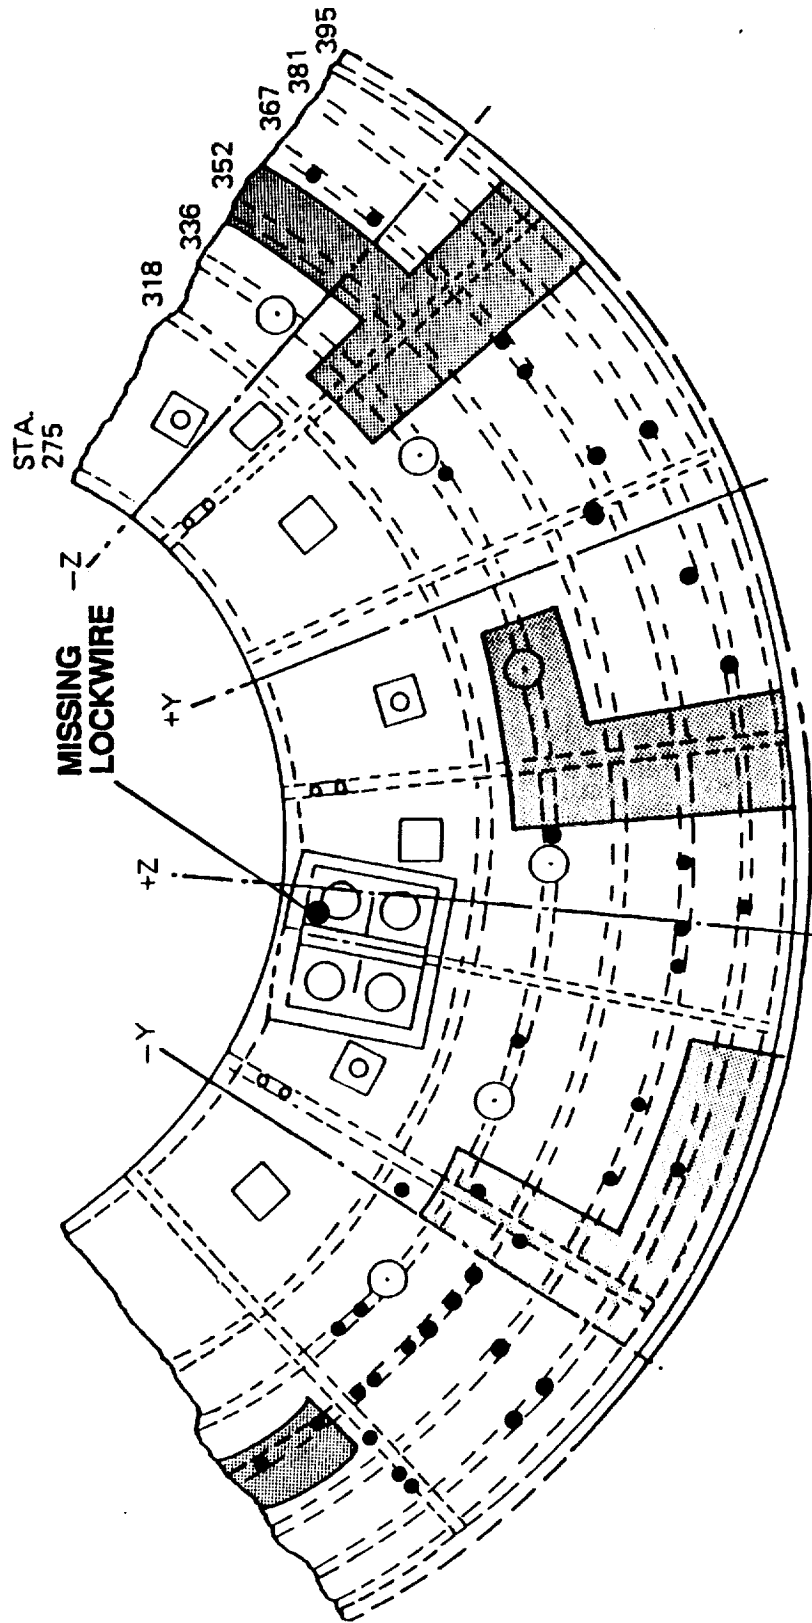
FIGURE 5. RIGHT SRB FRUSTUM

1. RH UPPER BSM COVER BENT BACK TO 135° POSITION
2. RH LOWER BSM COVER BENT BACK TO 100° POSITION
3. BLISTERING OF HYPALON PAINT. VARYING DEGREES OF CHARRING ALONG 395 RING

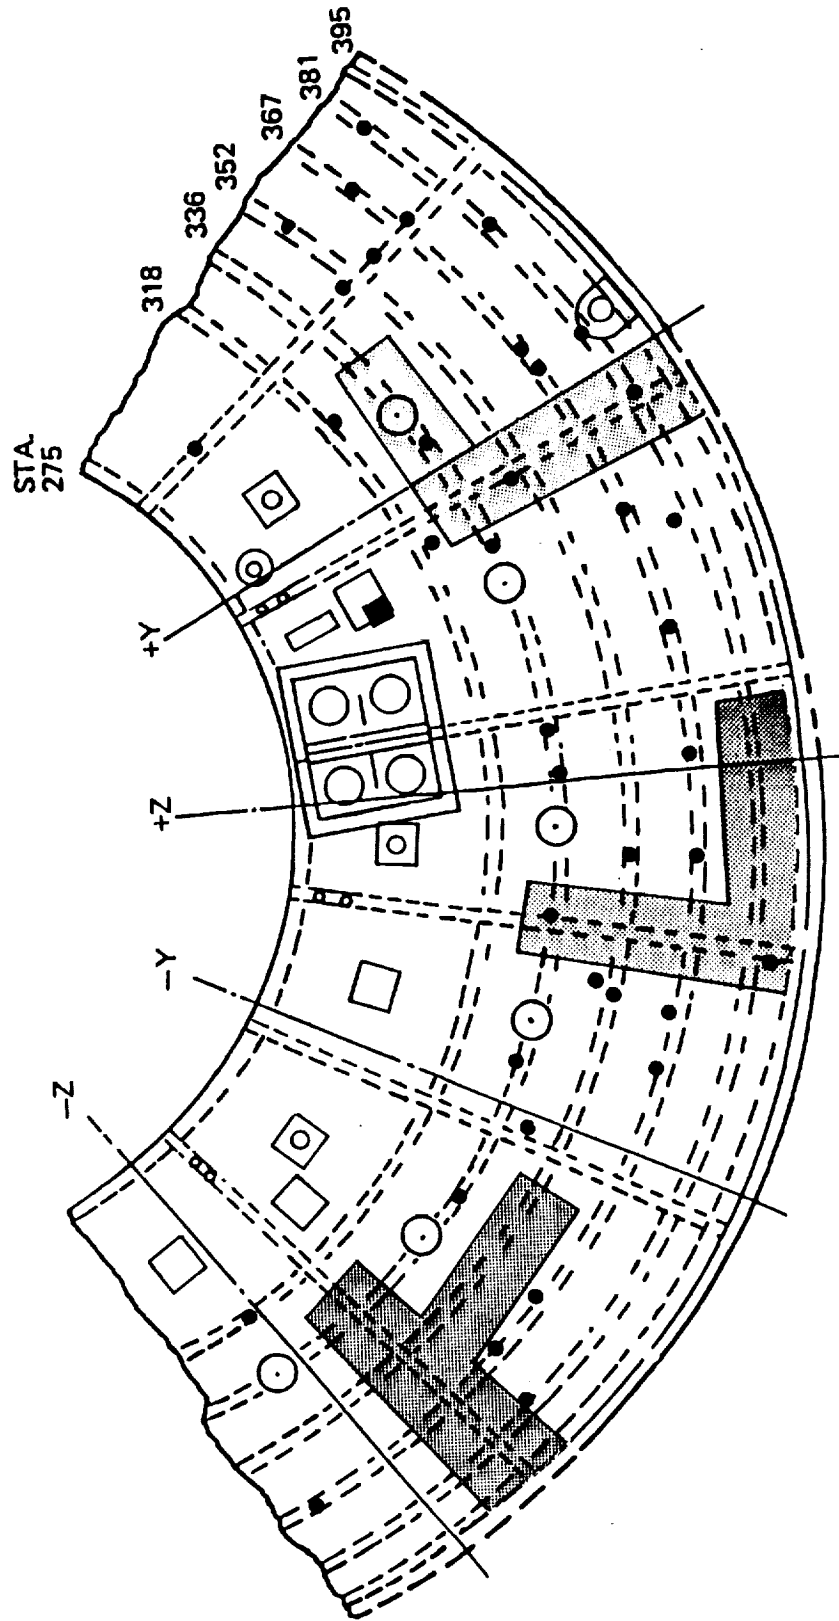
FIGURE 8. LEFT SRB FRUSTUM

The LH frustum exhibited no missing TPS but had 40 debonds over fasteners. A 3"x3" debond over a cluster of fasteners occurred near the +Y side of the BSM's (Figure 8). Three of the BSM covers were fully opened and locked in the 180 degree position. One BSM cover was locked but bent back to approximately 135 degrees.

1. VERY LITTLE BLISTERING/AERO HEATING EFFECTS
2. RH LOWER BSM COVER BENT BACK TO 90° POSN

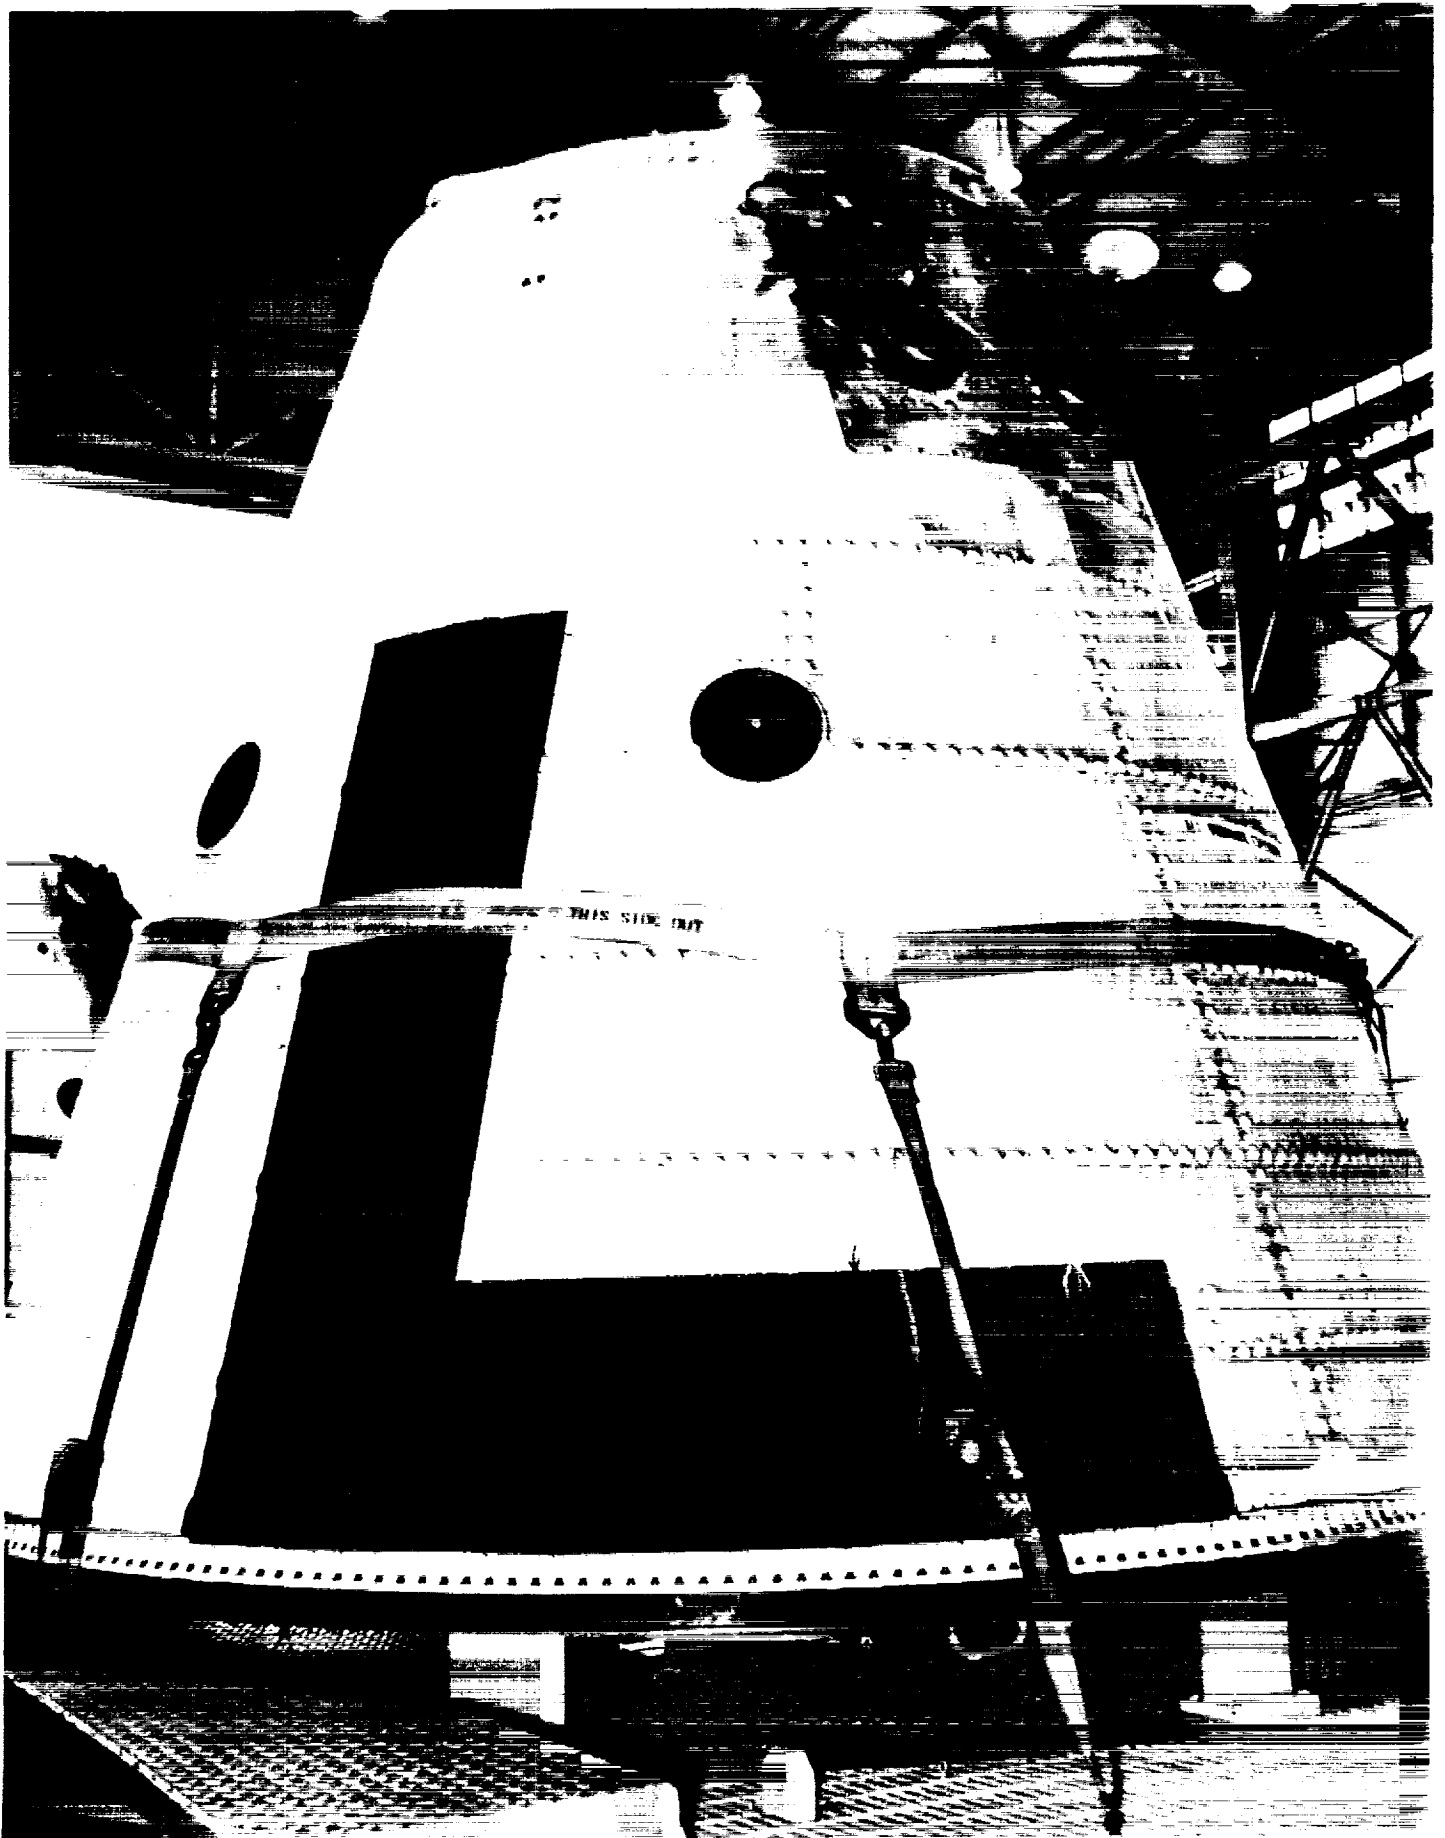
Post flight condition of RH frustum. Although no MSA-2 was missing, debonds over fasteners continue to occur.

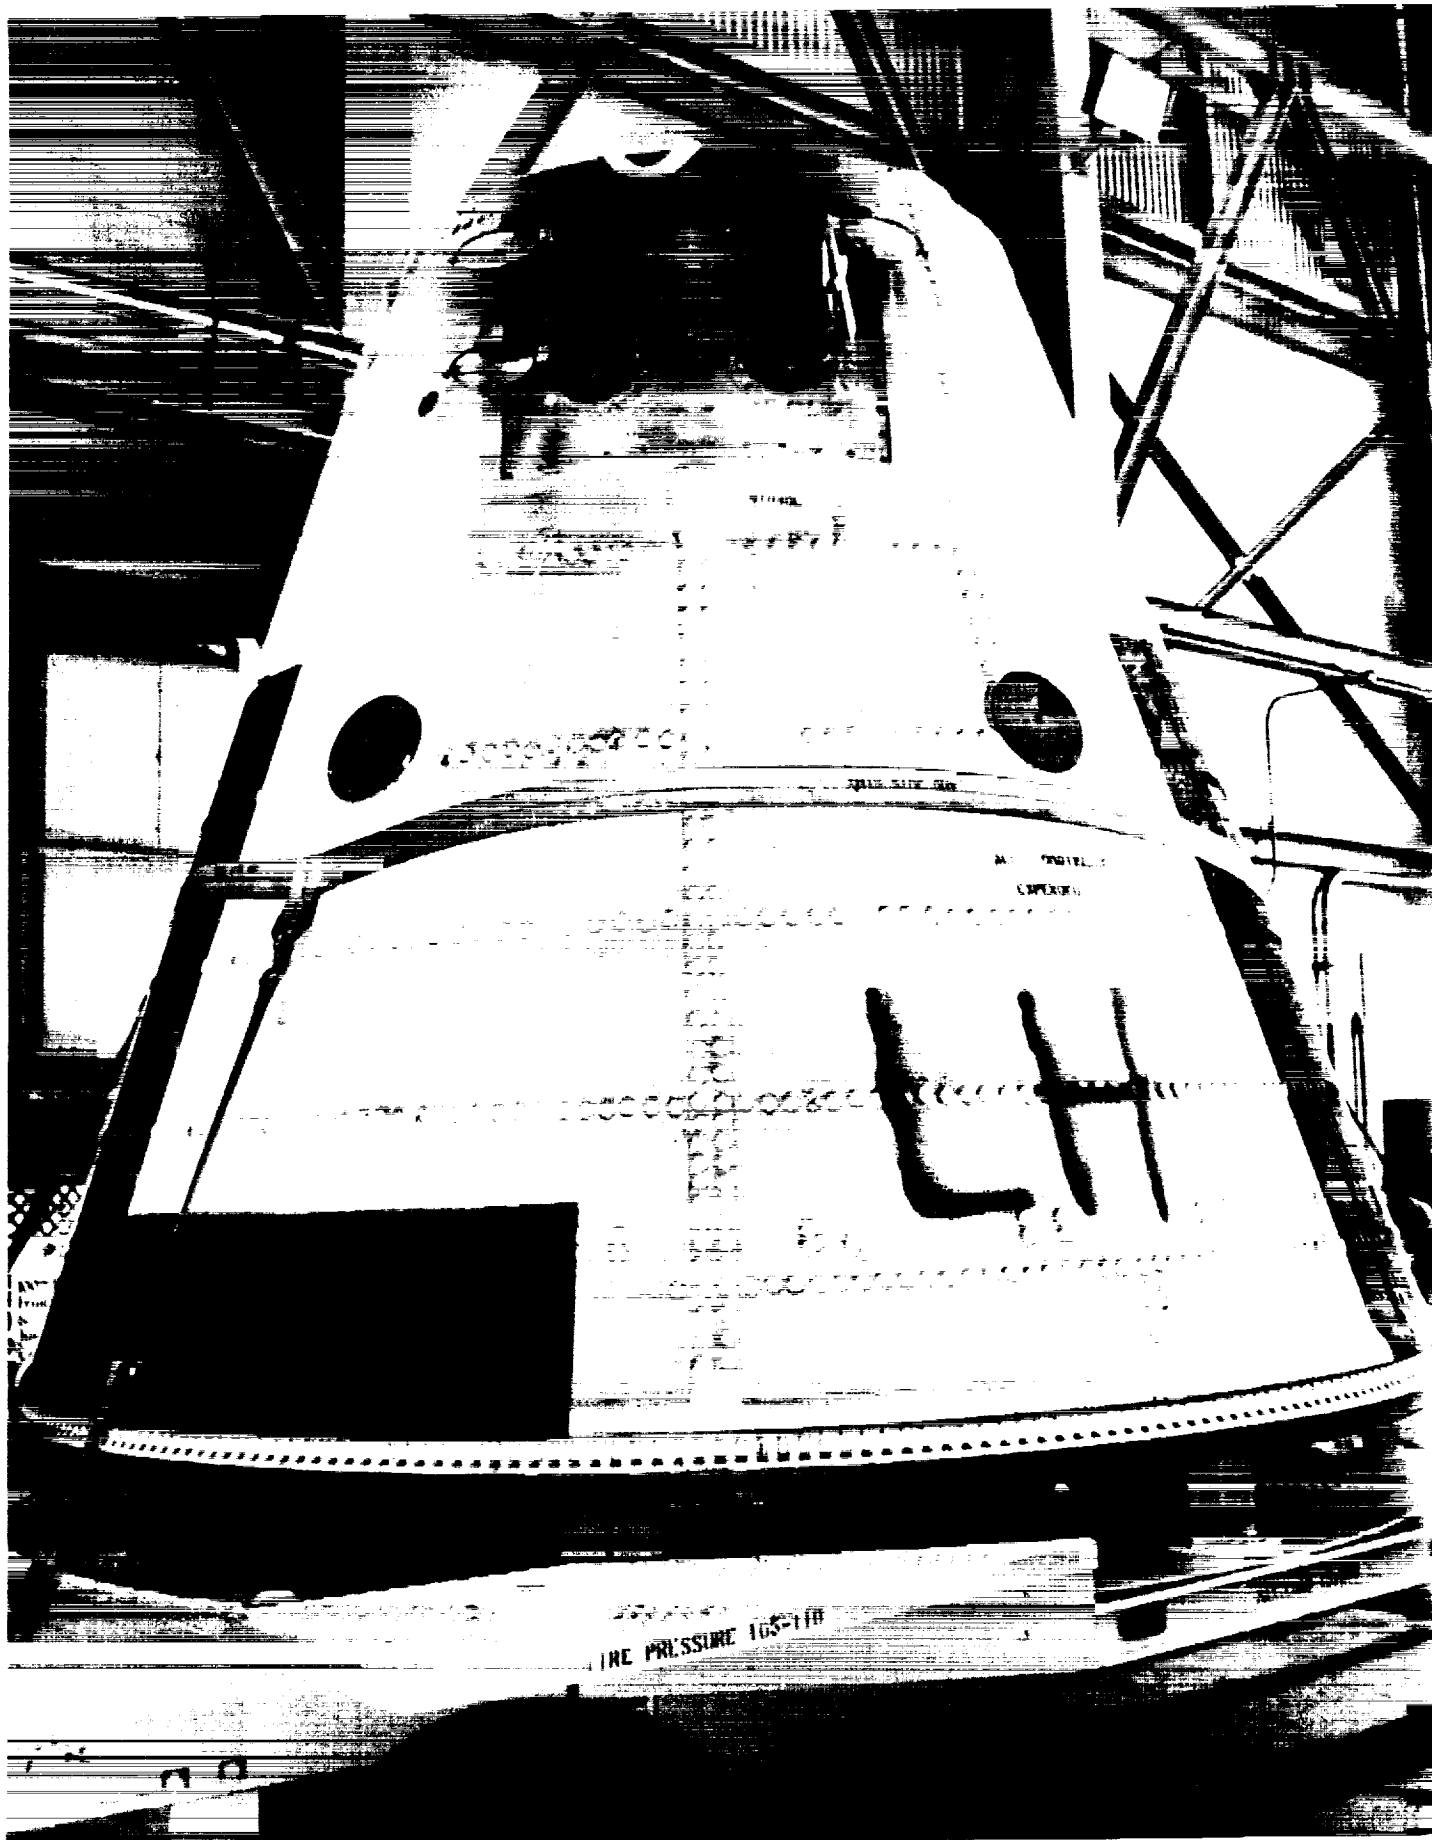
Post flight condition of LH frustum. Although no MSA-2 was missing, debonds over fasteners continue to occur.

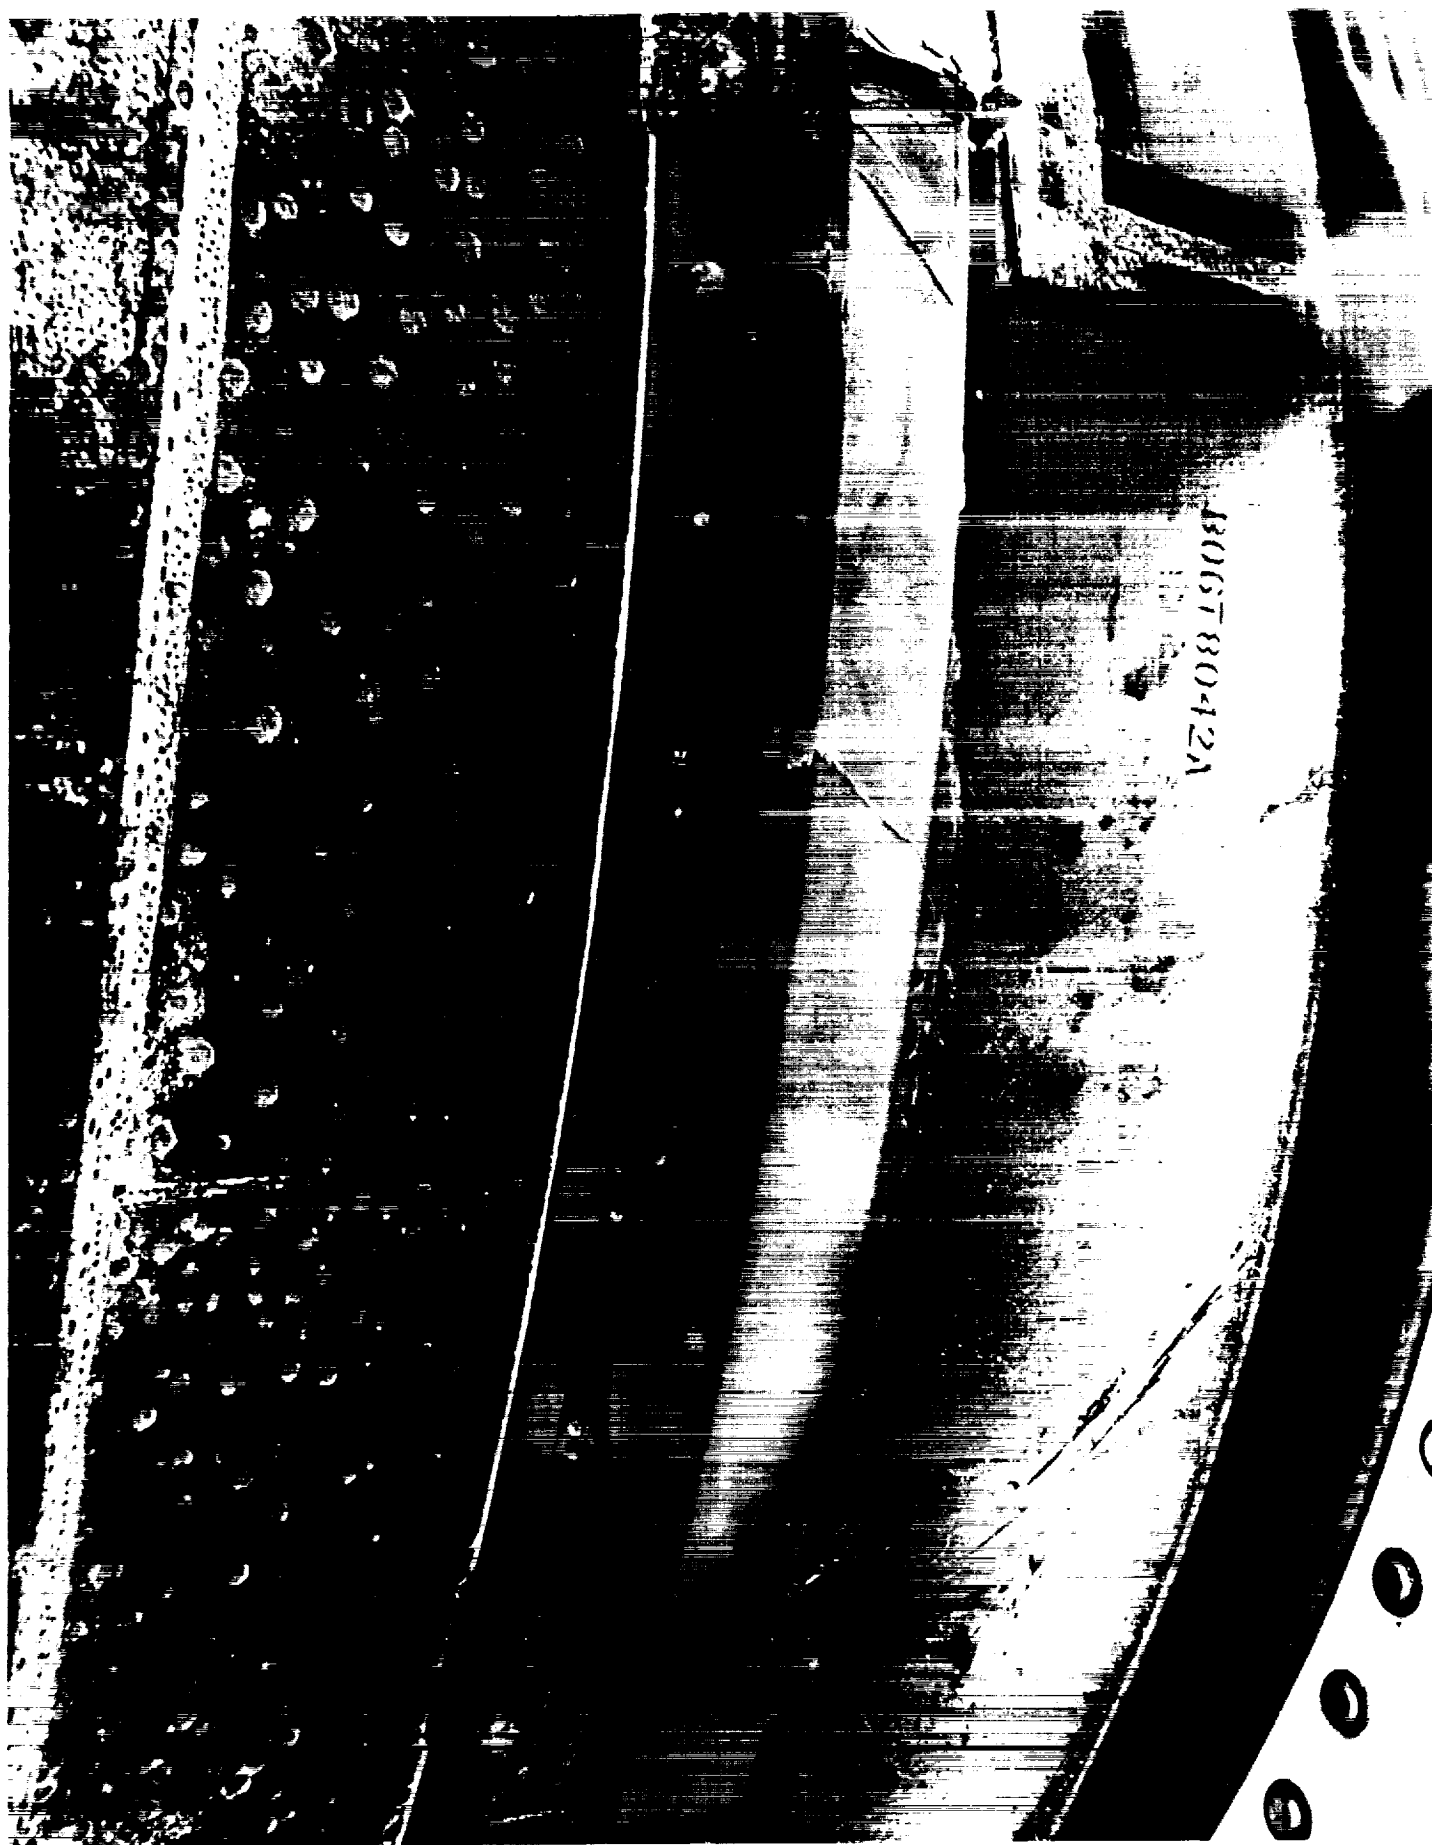
The phenolic material on the kick ring delaminated in several locations. K5NA protective domes on the aft side of the phenolic kick ring were missing in 6 places (220-270 degrees) prior to water impact. All four Debris Containment System (DCS) plungers were properly seated (Figure 7).

Phenolic material has delaminated from the kick ring. Note  
loss of K5NA protective domes prior to water impact.

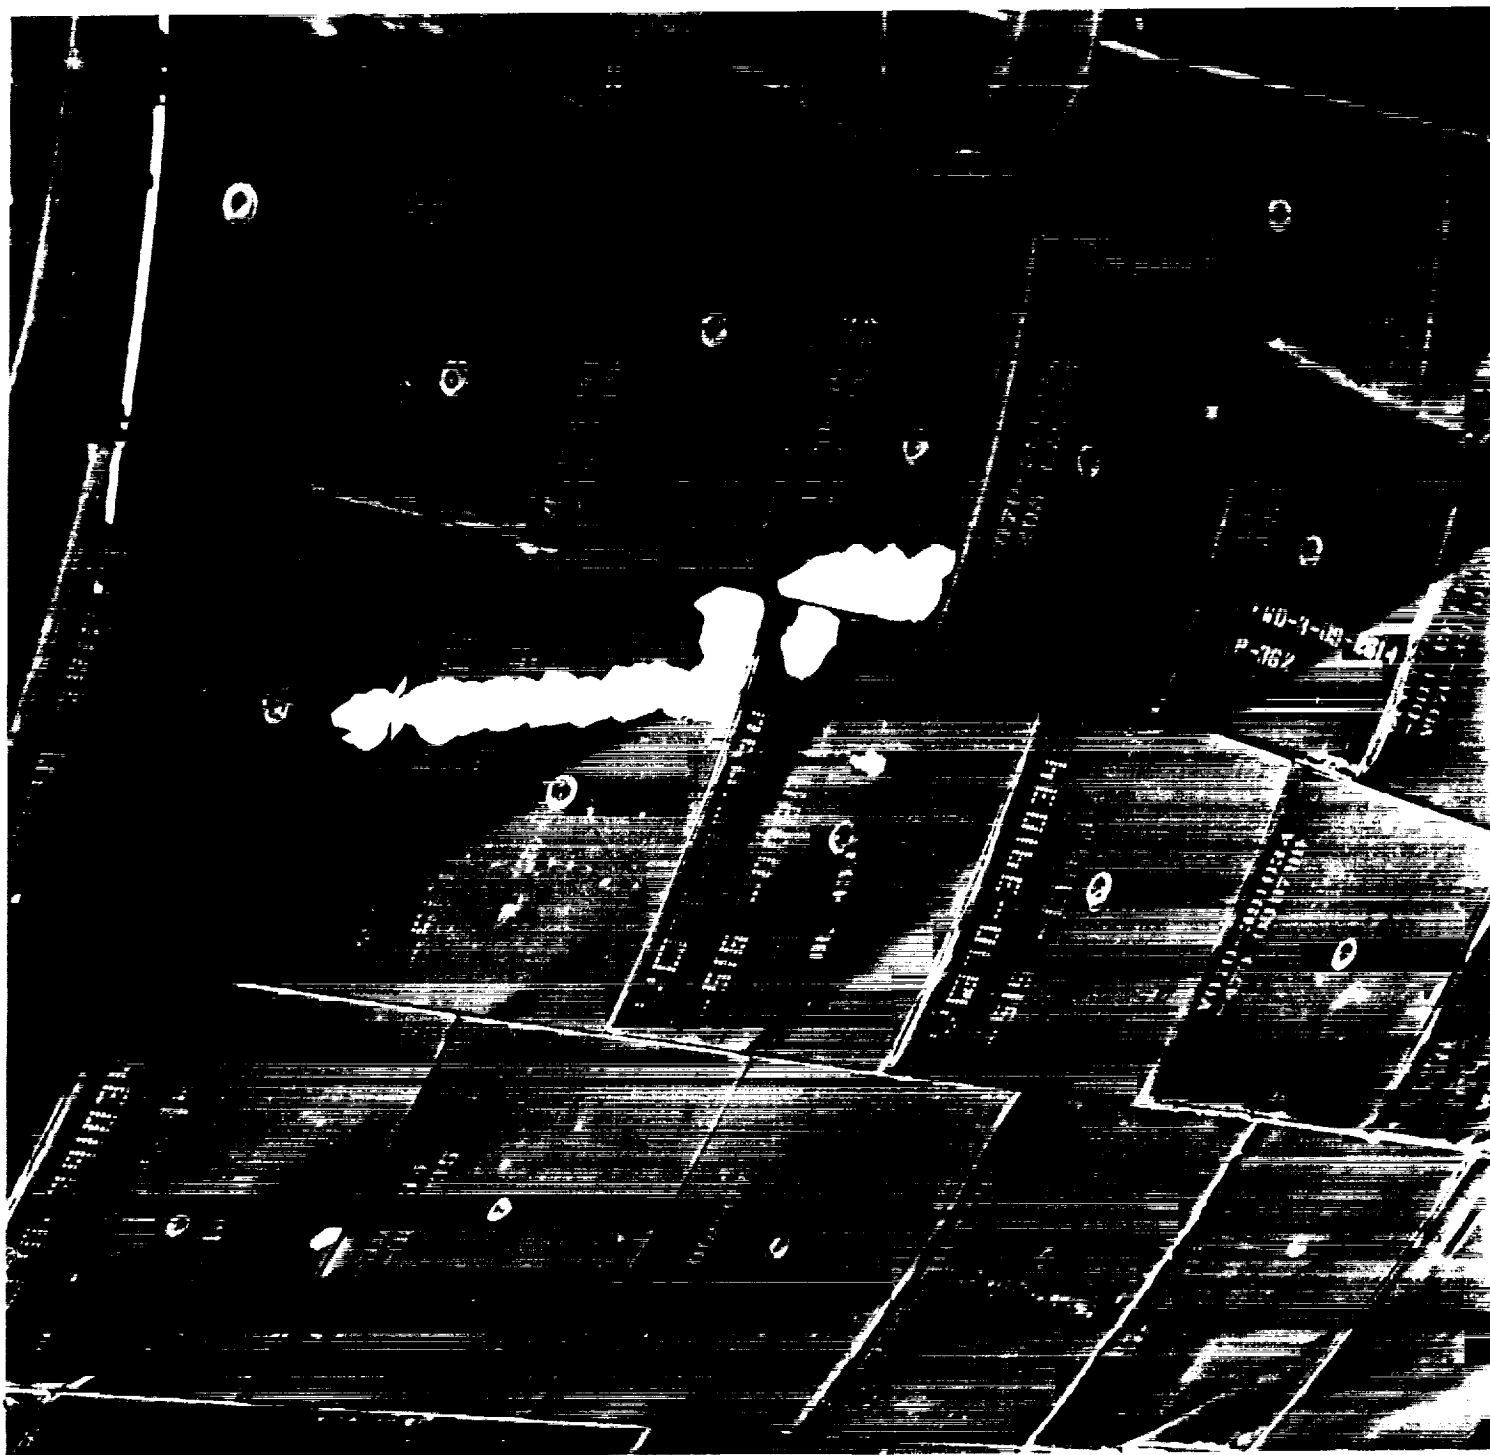
Surface coating material loss on four tiles below  
the crew module hatch

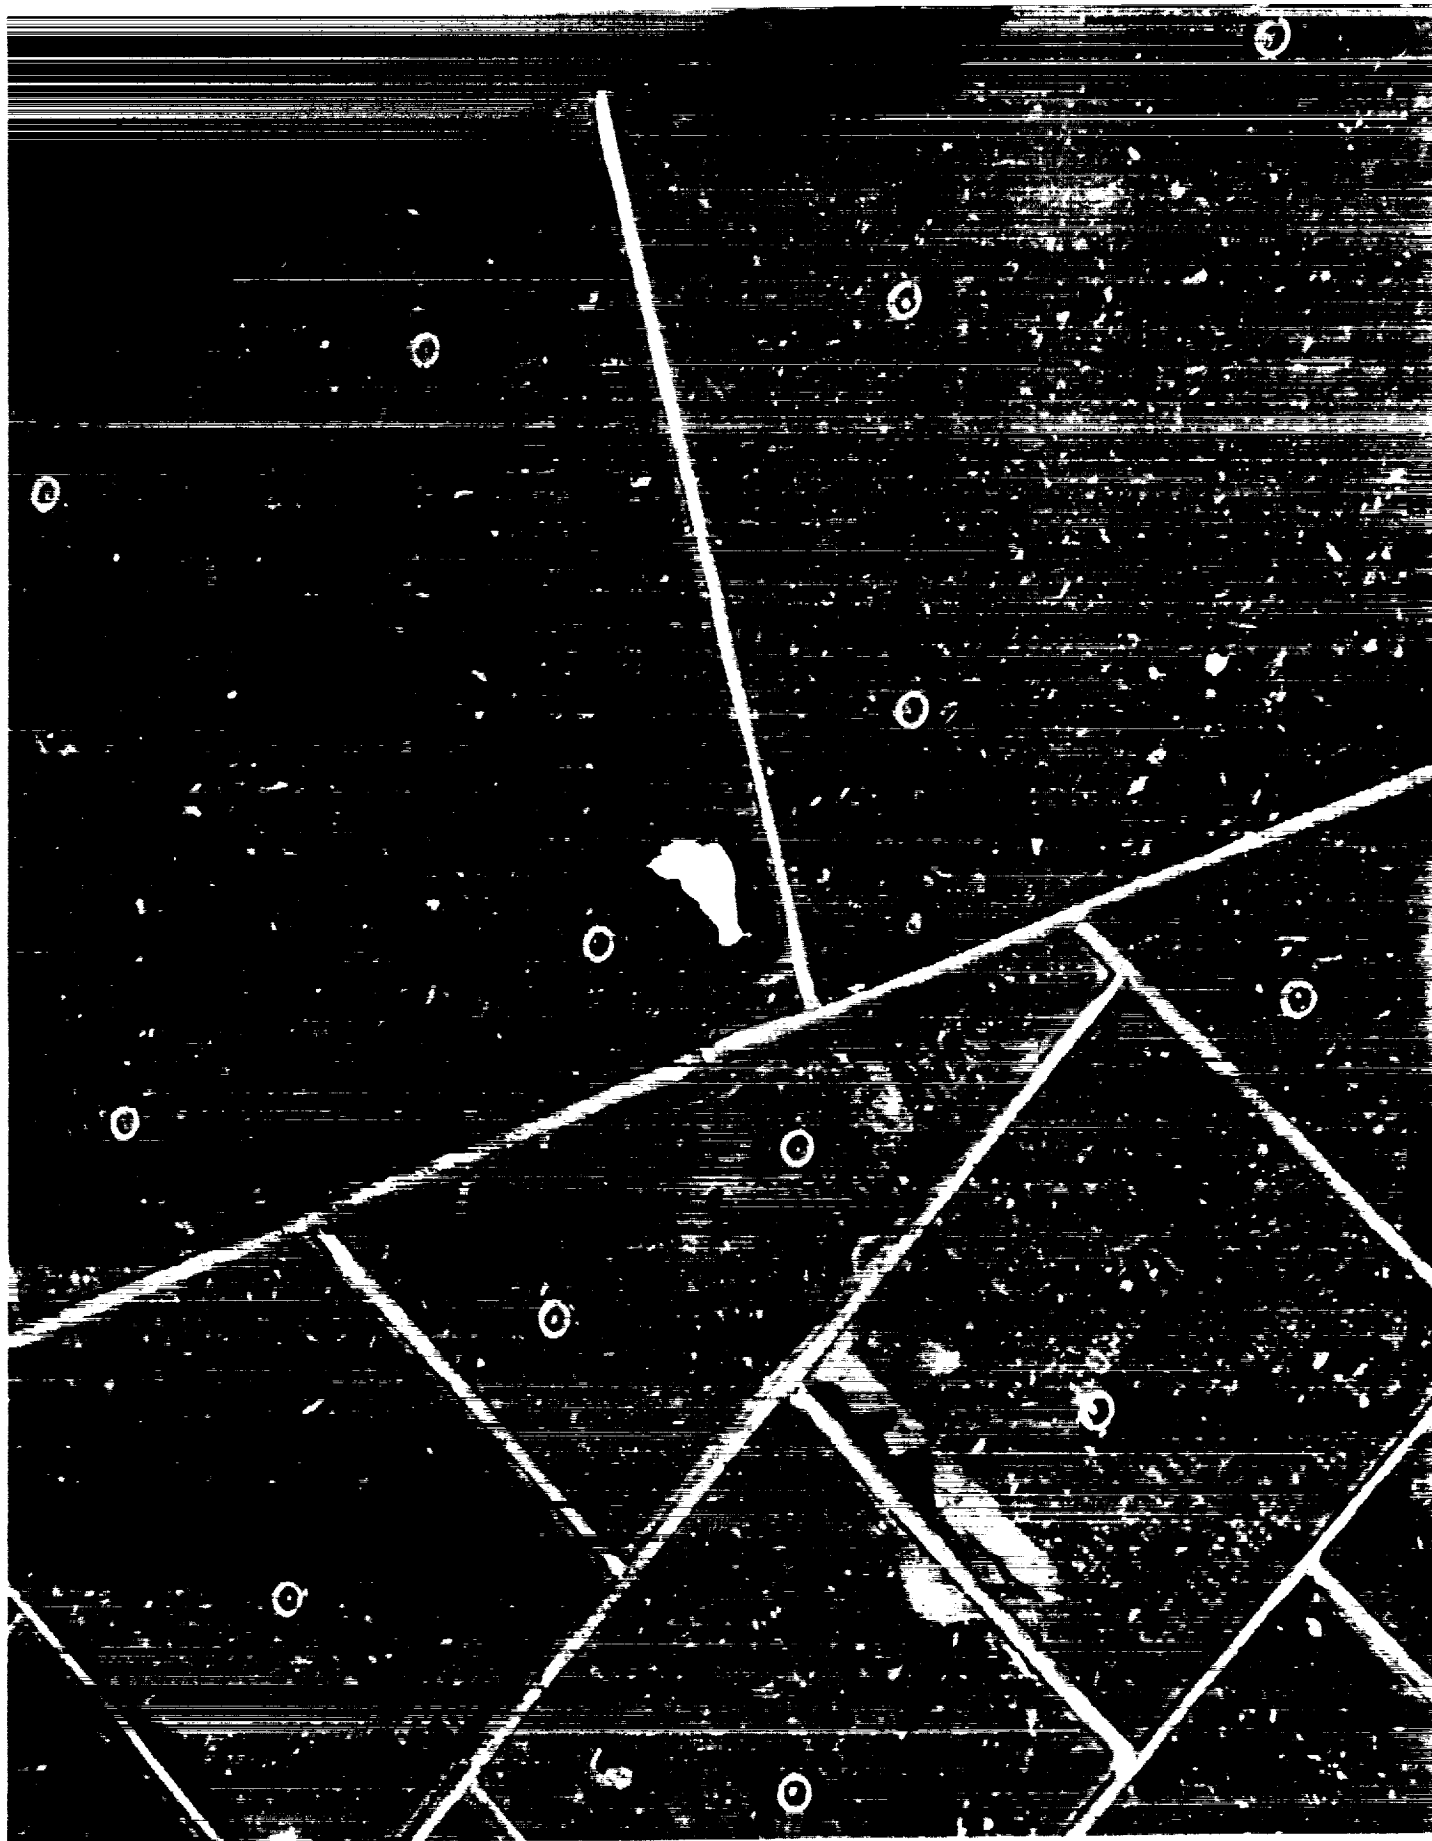
Typical tile damage from a debris impact on the body flap

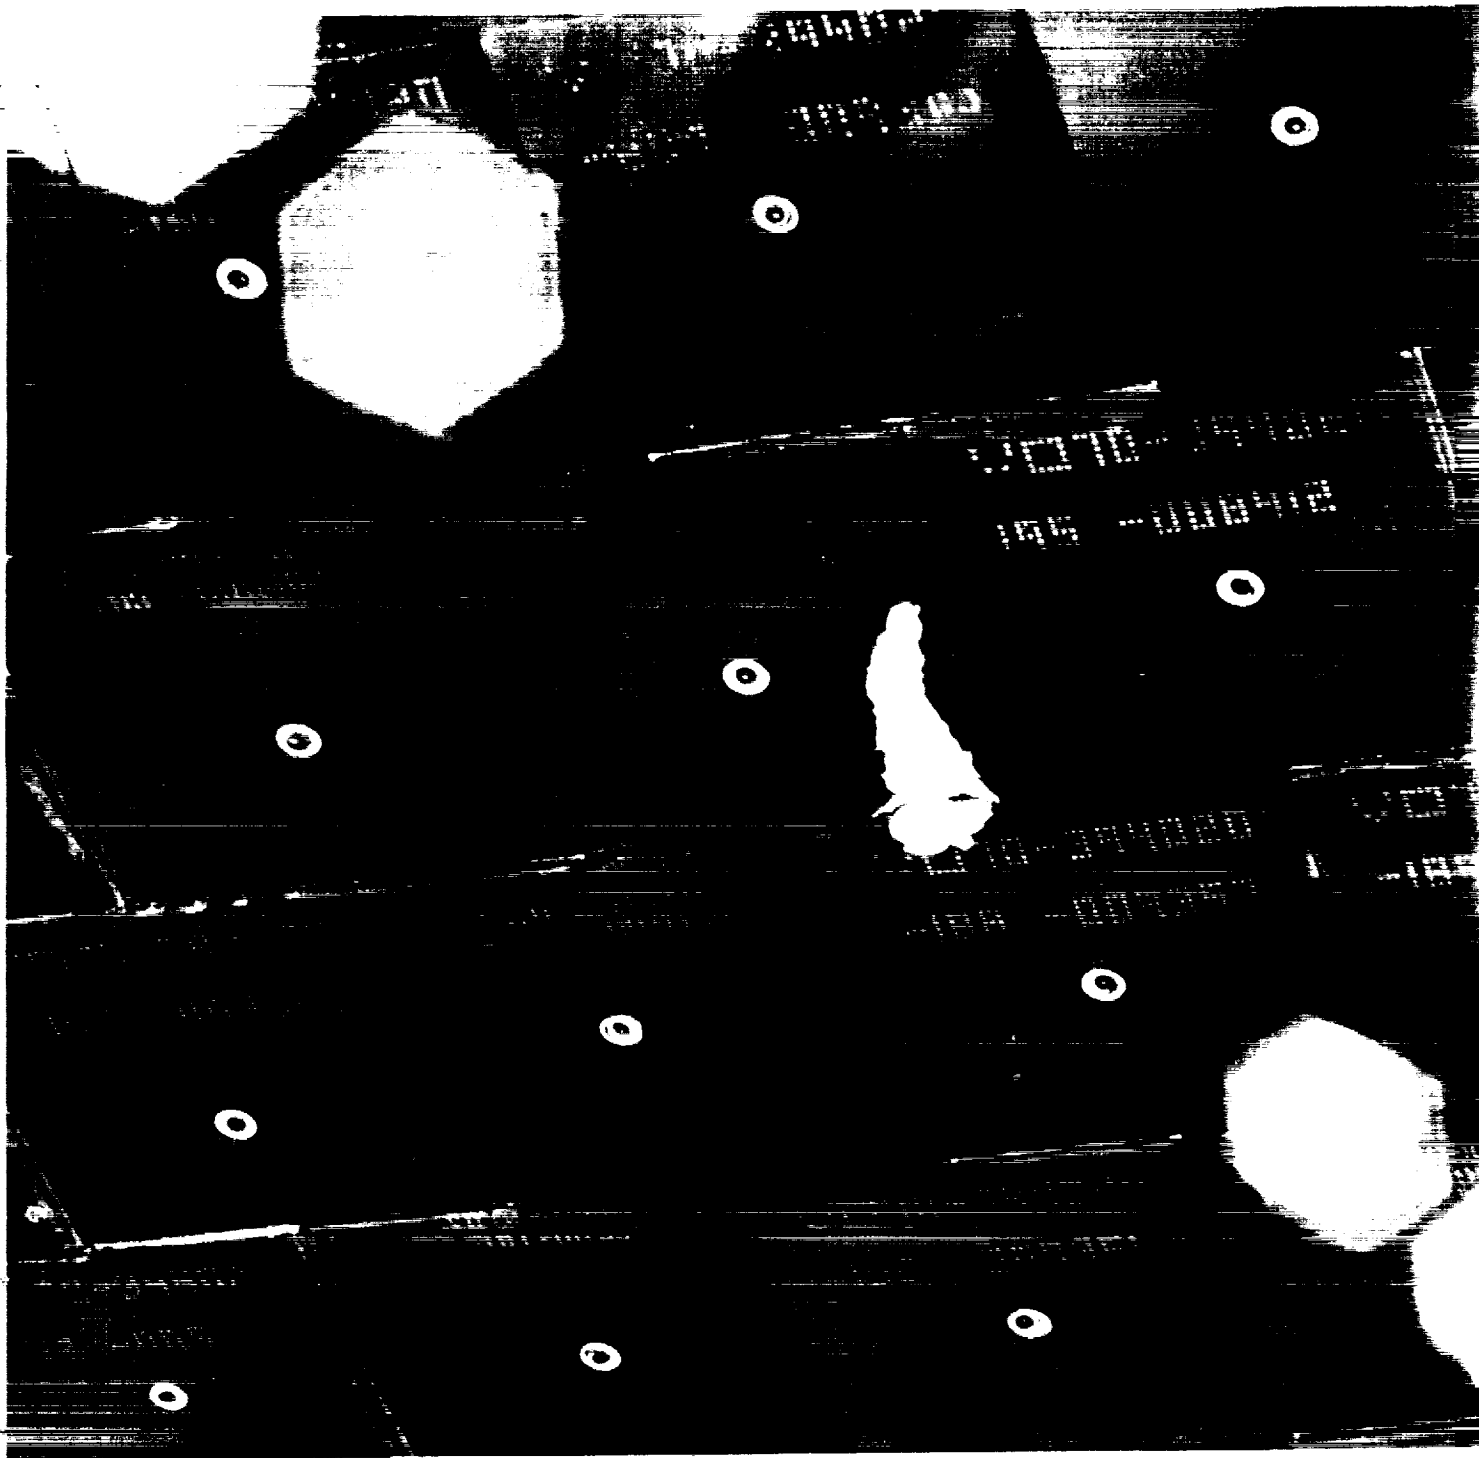
Typical lower surface tile damage from a debris impact

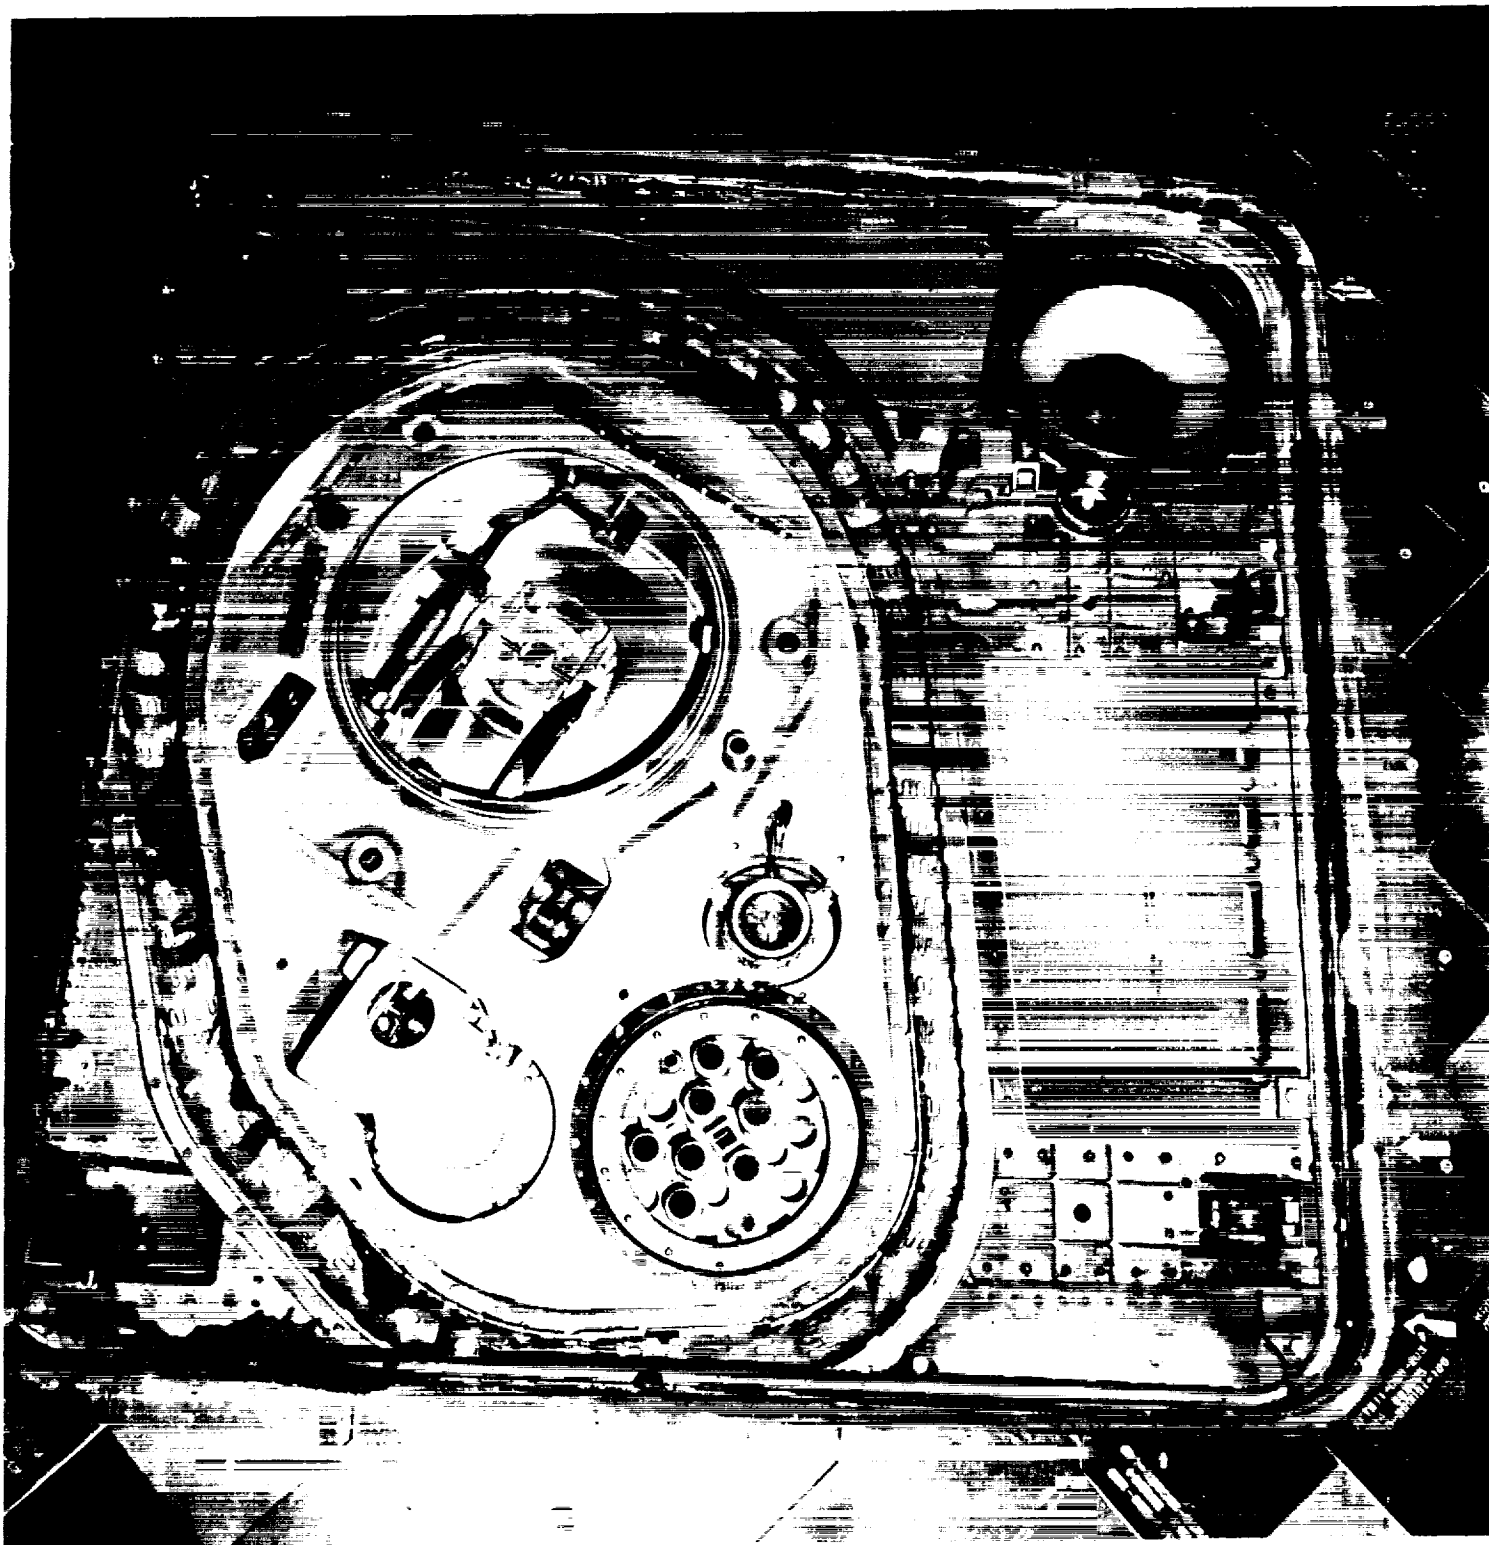
View of ET/ORB LH2 umbilical. Note presence of frangible nut  
piece obstructing E0-2 debris hole plugger.
